**AL MOUJ, MUSCAT**

Al Mouj, Muscat resort is developed along a 7 km beach plot, close to the Airport.

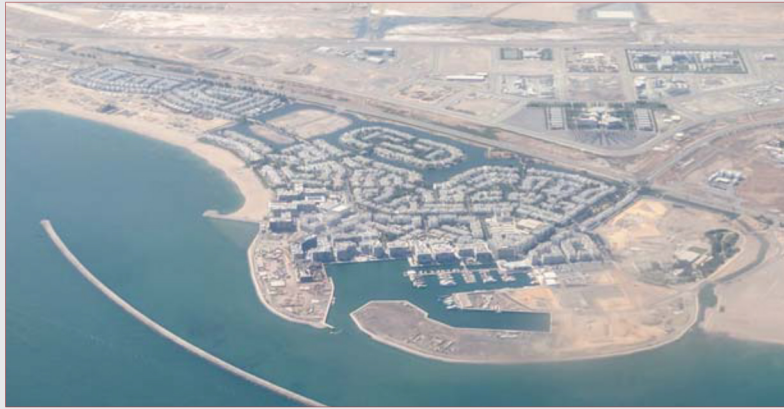
**AL MOUJ, MUSCAT AERIAL PHOTOGRAPH**

This project aerial photograph shows the marina harbour, the quay walls, the reef breakwater (2 km long), the reclaimed land, the new township, and some beach groynes.

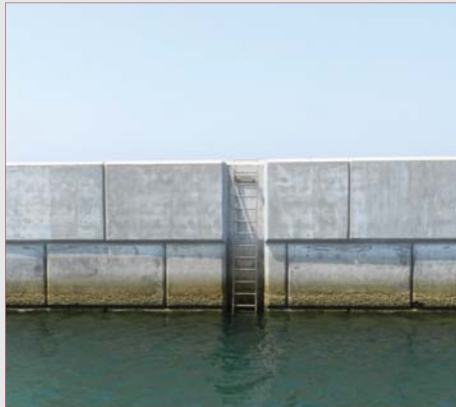
**QUAY WALL AND CAPPING BEAM**

The nearly 3 km long quay wall and capping beam were built to demarcate the marina and provide mooring facilities.

Stainless steel access ladders can be seen.

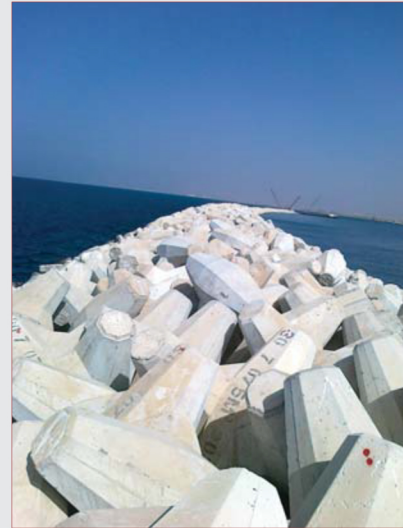
**CORE-LOCK PROTECTION**

A view of the reef breakwater crown.

It shows the final layer of pre-cast concrete units called 'Core-Lock'. The system is patented and the units are interlocked with each other and act as a mat. Raising one of them upwards lifts all the neighbouring ones at the same time.

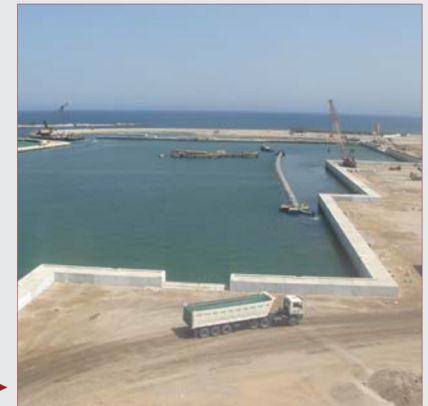
**MARINA BASIN**

The marina basin can be seen practically complete.

Breakwaters, quay walls, and reclaimed areas.

One could also see a section of the HDPE pipeline floating ready to be towed and sunk in its final position.
